## DIO 3/ VOLUME 3

# TEHNIČKE SPECIFIKACIJE - TECHNICAL SPECIFICATIONS/

### **1. Postojeće stanje objekta / The existing condition of the building**

### *1.1. Analiza postojećeg stanja krova / Analysis of the existing condition of the roof*

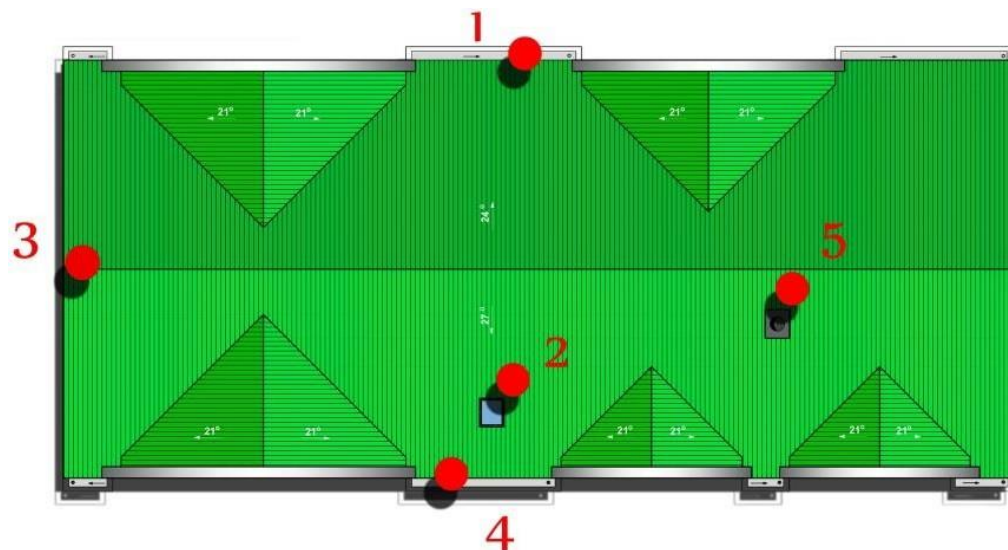
*Slika 1/Photo 1: Grafički prikaz krova sa pozicijama evidentiranih oštećenja/ Graphic representation of the roof with positions of recorded damage*

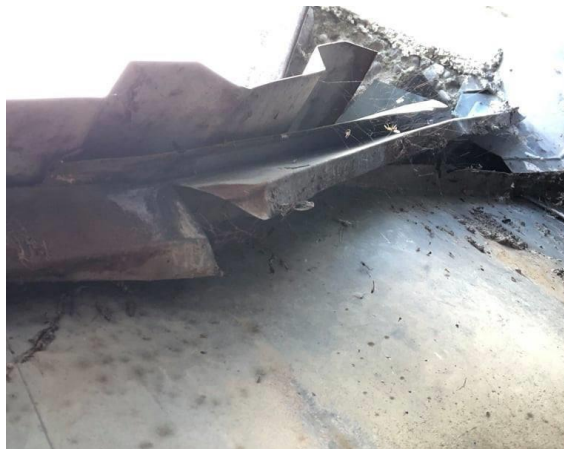
*Oštećenje vodnih limova/ Damage to water sheets*

*2.1.2. Demontaža starog oluka i opšivanje horizontalnog oluka novim pocinčanim limom  $d = 0.68$  mm dužine 18.5m. Opšivanje je duplo i sa preklapom i treba ga izvesti po tehničkim propisima i detalju iz projekta. Razvijena širina lima je 90 cm. Obračun po m<sup>2</sup> kompletno izvedenog oluka./* Dismantling of the old gutter and hemming horizontal gutter with new galvanized sheet metal  $d = 0.68$  mm. The hemming is double and with overlap and should be done by technical regulations and project details. Developed the width of the sheet is 90 cm, length is 18.5m. Calculation per m<sup>2</sup> of complete gutter m<sup>2</sup>.

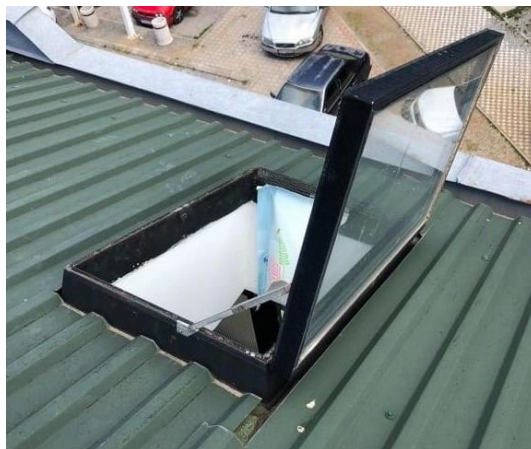
*Nedostatak opšivki krovnog revizionog otvora/ Lack of heming on the roof opening*

**2.1.12. Izrada i montaža opšivki oko krovnog revizionog prozora plastificiranim limom debljine  $d=0,55$  mm razvijene širine do 700mm sa formiranjem potrebnih prevoja i okapnica. Obračun po m' kompletno izvedene pozicije./** Production and installation of cladding around the roof inspection window with plasticized sheet metal thickness  $d = 0.55$  mm developed width up to 700 mm with the formation of the necessary bends and drips. Calculation per m 'of a completely performed position.

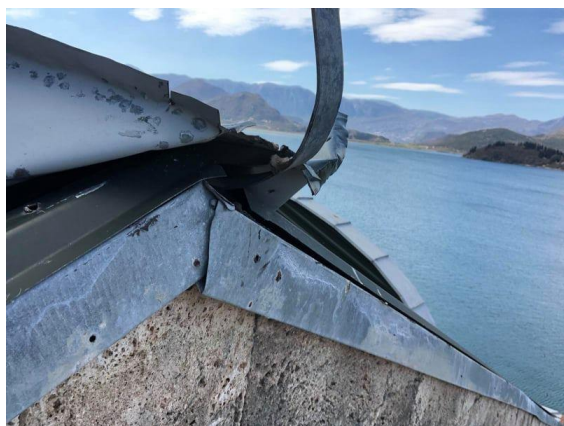
*Oštećenja šljemena krova i krajnje opšivke/  
Damage to the roof ridge and end trim*

**2.1.8. Opšivanje vrha krova novim plastificiranim limom u dužini od 26 m , razvijene širine (RŠ) do 700 mm, debljine 0,55 mm. Opšivanje izvesti po detaljima i uputstvu projektanta. Obračun po m' kompletno izvedene pozicije./** Sheathing the top of the roof with new plasticized sheet metal in the length of 26 m, developed width (RŠ) up to 700 mm, thickness 0.55 mm. Trimming according to the details and instructions of the designer. Calculation per m 'of a completely performed position.

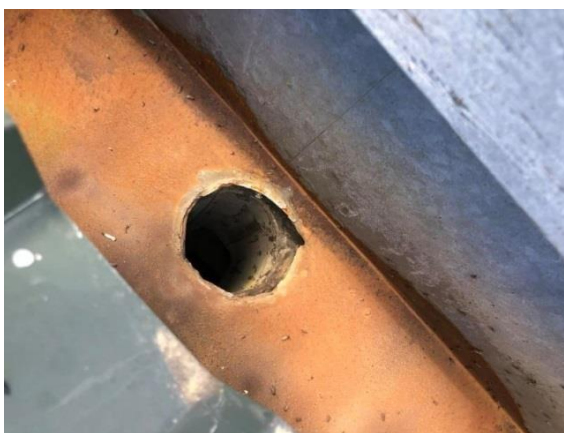
*Oštećenja hidroizolacije u olucima/ Waterproofing damage in gutters*

**2.1.6. Izrada hidroizolacije betonskih olučnih kanala dužine 18.5. m razvijene širine 75 cm. Radi se u premaza poliazbitolom i mrežicom ili slično. Obračun po m' kompletno izvedenog oluka./** 2.1.6. Construction of waterproofing of concrete gutters 18.5. m developed width of 75 cm. It works in coatings with polyazbitol and mesh or similar. Calculation per m 'of a complete gutter.

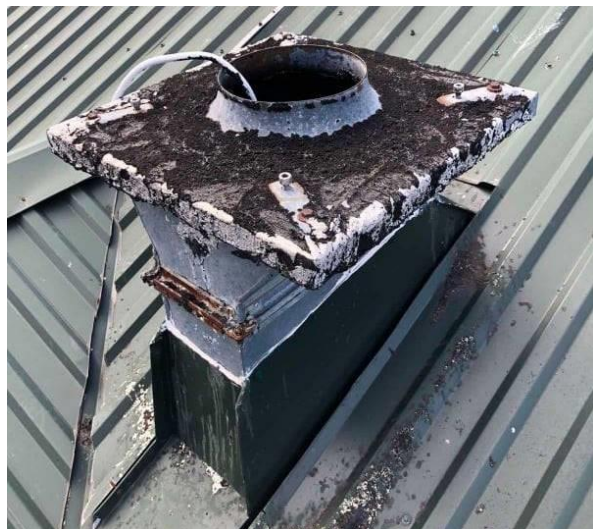
*Nedostatak ventilacione kape/ Lack of ventilation cap trim*

**2.1.11. Izrada i montaža ventilacione kape ventilacionog kanala ili dimnjaka. Ventilaciona kapa je od metalne konstrukcije i opšiva se plastificiranim limom  $d=0,68$  mm. Na vrhu - završetku ventilacione kape je zaštitna čelična mrežica, protiv ptica i glodara. Obračun po kom izvedene pozicije./** Production and installation of ventilation duct of ventilation duct or chimney. The ventilation cap is made of metal construction and is lined with plasticized sheet metal  $d = 0.68$  mm. At the top - the end of the ventilation cap is a protective steel mesh, against birds and rodents. Calculation according to which derived positions.

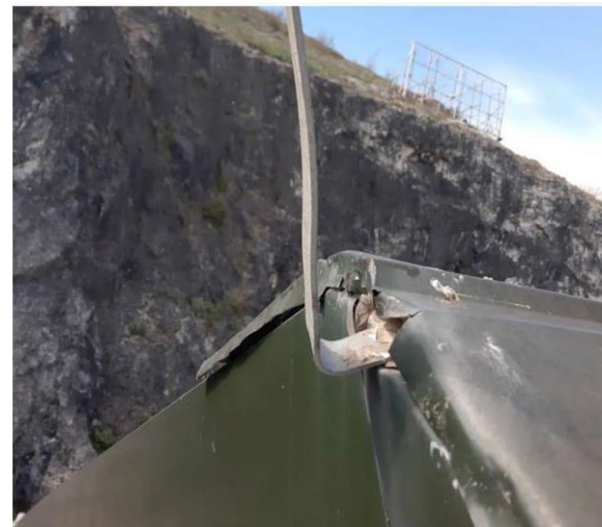
*Oštećenje šljemena krova i krajnih opšivki / Damage to the roof ridge and end*

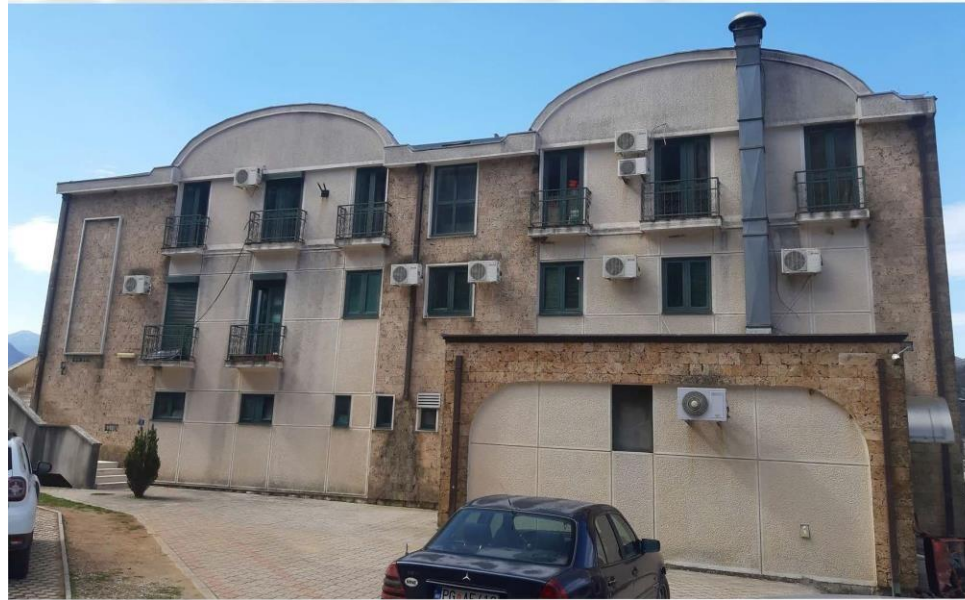
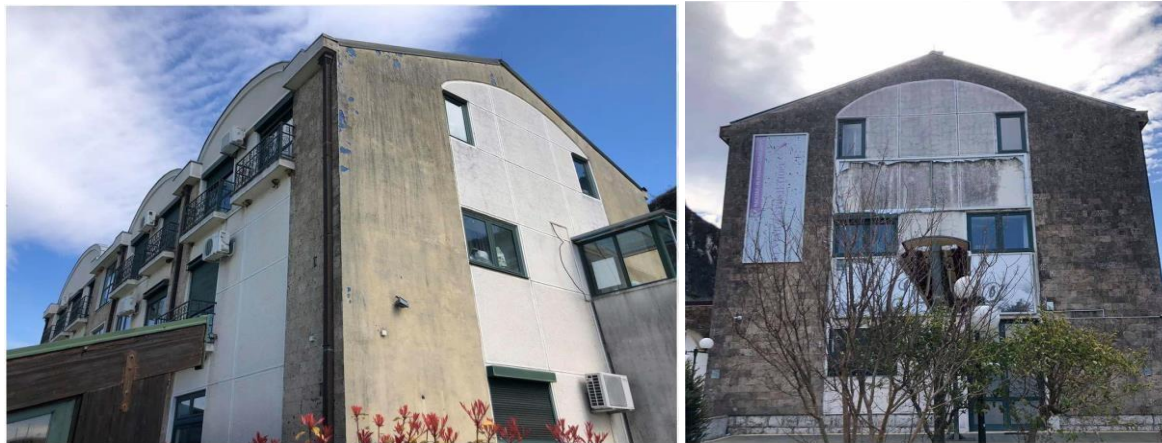
*Postojeća fasada objekta je u lošem stanju. Evidentno je da su odvojene površine maltera, zatim nepostojanje termizolacionih slojeva, oštećena boja kao i pojava plijesni usljed duge izloženosti dejstvu atmosferskih padavina./ The existing facade of the building is in poor condition. It is evident that the separate surfaces of the mortar, then the absence of thermal insulation layers, damaged paint and the appearance of mold due to long exposure to atmospheric precipitation*
